ENGINEERING ANALYSIS CLOSING REPORT

SUBJECT: Speed Control Deactivation Switch Fires.

EA No: EA05-005

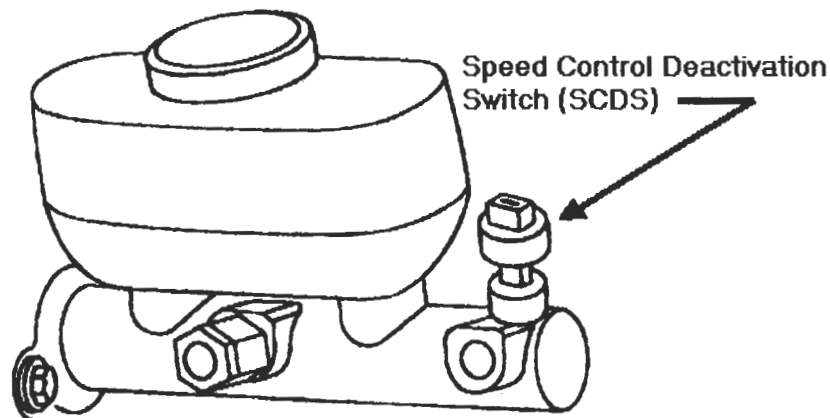
Figure 3. Speed Control Deactivation Switch Location.

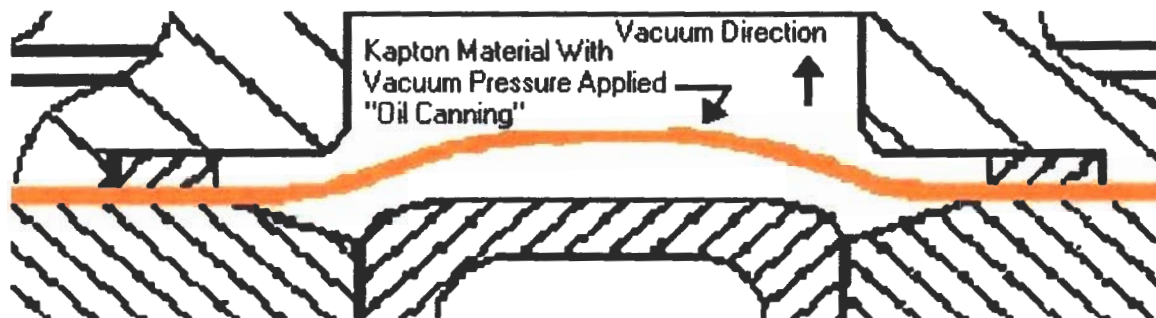
Impulse cycle testing is performed on the switches in order to demonstrate that the switch is capable of surviving the expected lifetime of brake applications on the vehicle. However the design specifications apparently did not account for a vacuum pressure experienced by some Ford model vehicles just after a braking event, when the brake pedal is released by the driver. The duration and magnitude of the vacuum pressure varies from model to model and model year to model year. In some models the magnitude of the vacuum pressure is great enough to cause the Kapton “set” to invert or “oil can”. This change in orientation of the Kapton material each time the brake pedal is released causes the Kapton material to fatigue and wear out much sooner than if the diaphragm had only experienced pressure applications in one direction. Figure 6. shows the Kapton orientation when a vacuum pressure is being applied.

Figure 6. Kapton With Vacuum Applied.

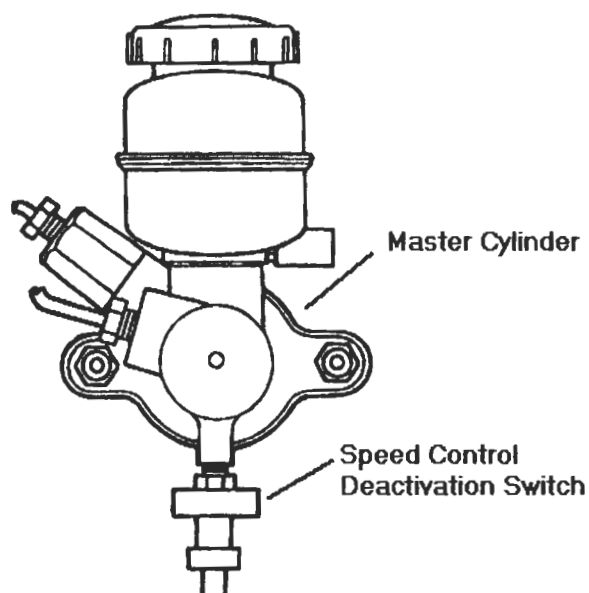
SCDS Orientation. Orientation of the SCDS as mounted in the Master Cylinder is another factor contributing to the alleged defect. When the electrical contacts start to corrode and corrosion products, metallic debris, and electrolysis products start to form, they move downward in the solution inside of the electrical cavity. These corrosion products move downward as a result of being denser than the brake fluid solution. Normal vehicle vibration also helps facilitate the downward settling of these products. In order for the short circuit to develop, these corrosion products must settle in such a way that dendrite growth might start and develop. When the SCDS is mounted in the master cylinder in a vertically down orientation (Figure 7.) it is believed that the metallic corrosion products settle in the plastic base of the switch completely away from the grounded hexport body. With the metallic debris settled away from the grounded hexport body, dendrite growth is inhibited and a short circuit does not develop. When the SCDS is mounted in a vertically up or angled down orientation (Figures 8. and 9.), the metallic corrosion products can settle in such a way that dendrite growth can develop.

Figure 7. SCDS Vertical Down.

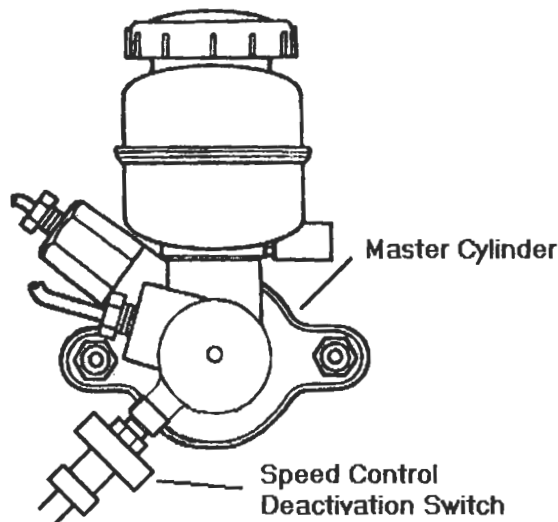
Figure 8. SCDS Angled Down.

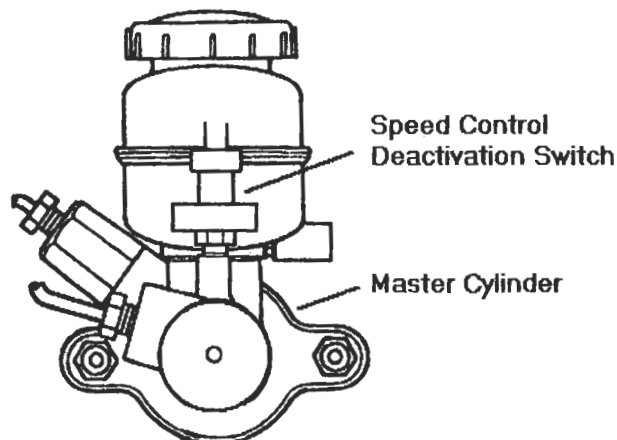
Figure 9. SCDS Vertical Up.

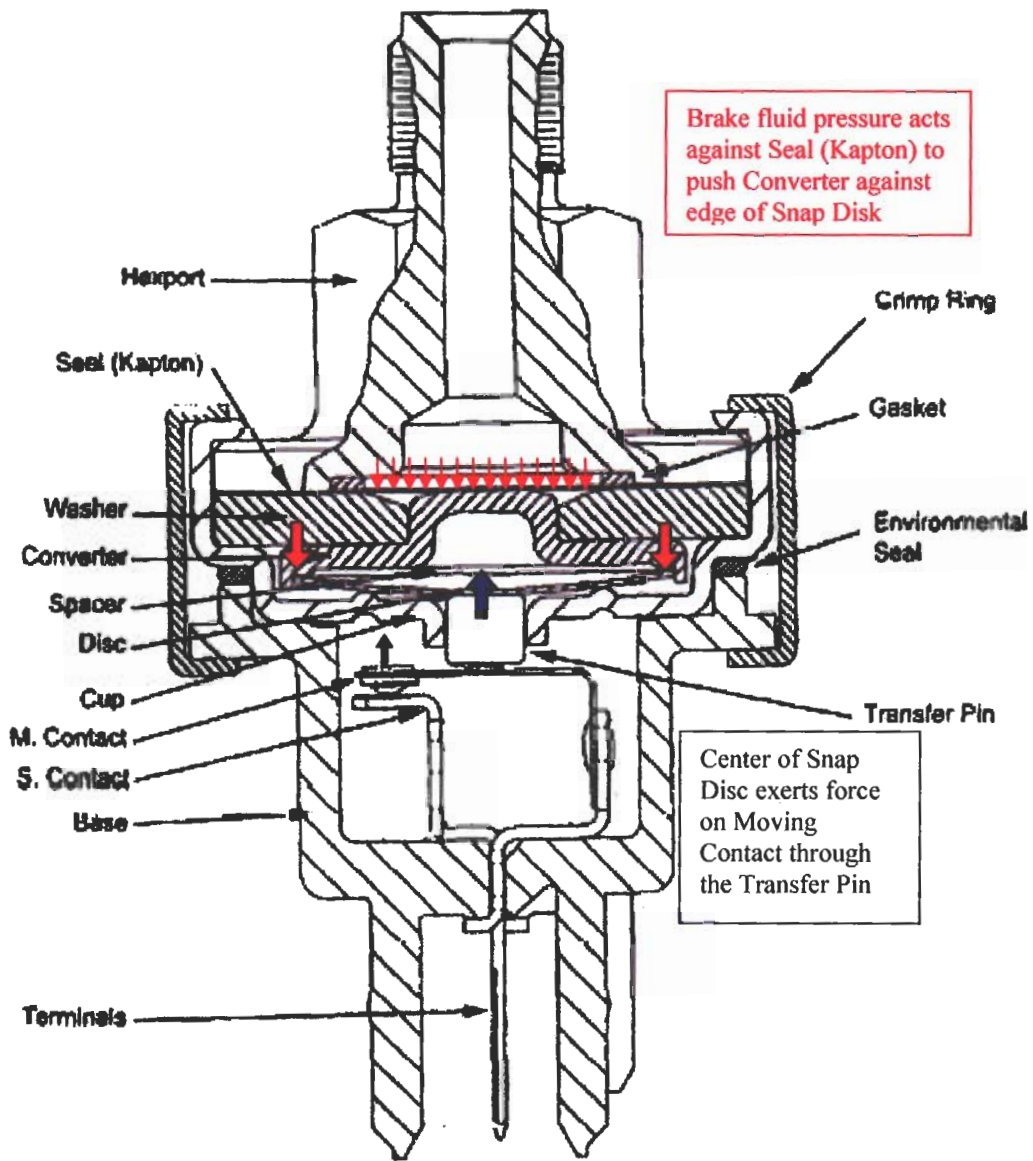
hydraulic brake fluid, and a “dry” side that interfaces with the electrical wiring to the cruise control servo and contains electrical contacts that open and close disengaging the cruise control when the brakes are applied. A multi-layer diaphragm and gasket seal the interface between the hydraulic and electrical sides of the switch (Figure 12.). The diaphragm consists of three layers of Kapton 500FN131 (Kapton sandwich), a high performance polyimide polymer film supplied by DuPont. Each Kapton FN layer is a composite structure consisting of a 3 mil (76.2 μm) core of Kapton HN film with 1 mil (25.4 μm) laminates of Teflon FEP on each side. TI used three layers of Teflon-coated Kapton to enhance the durability of the switch. The Kapton sandwich (hexport seal, middle seal, and washer seal) is clamped between the hexport cup and the washer with a gasket on the hexport side (Figure 12.).

Figure 12. Speed Control Deactivation Switch.

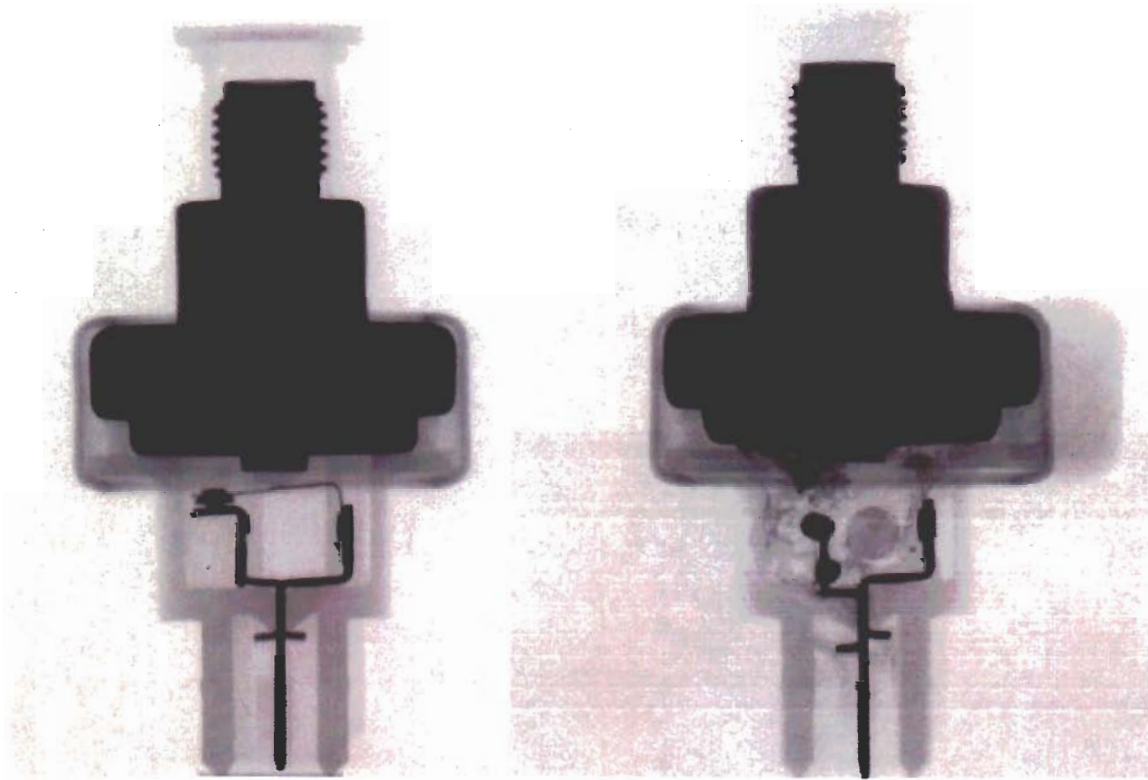
Examples of arc generated brass and copper beads and the resulting melted base of a failed SCDS can be seen in x-ray images and photos of a failed switch obtained by ODI from a complainant's vehicle (Figures 15. and 16.). This x-ray image is one of over fifty that ODI has taken of failed switches that have been collected from complainant vehicles. These x-ray images are consistent with ODI's analysis and the analyses performed by and for Ford.

Figure 15. SCDS electrical cavity before and after contact corrosion and arcing.

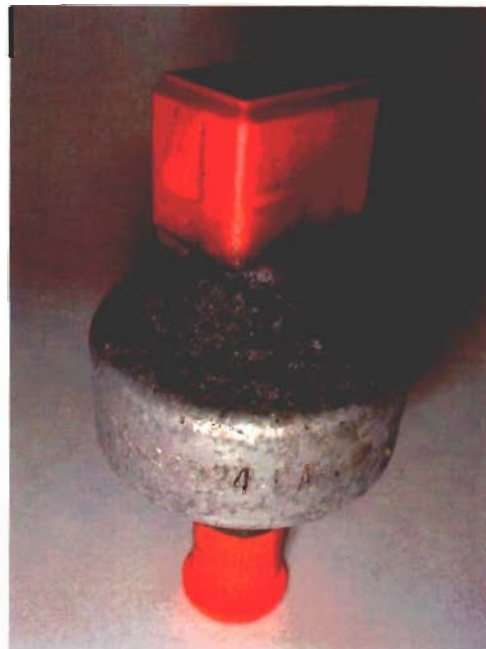
Figure 16. SCDS with melted base.

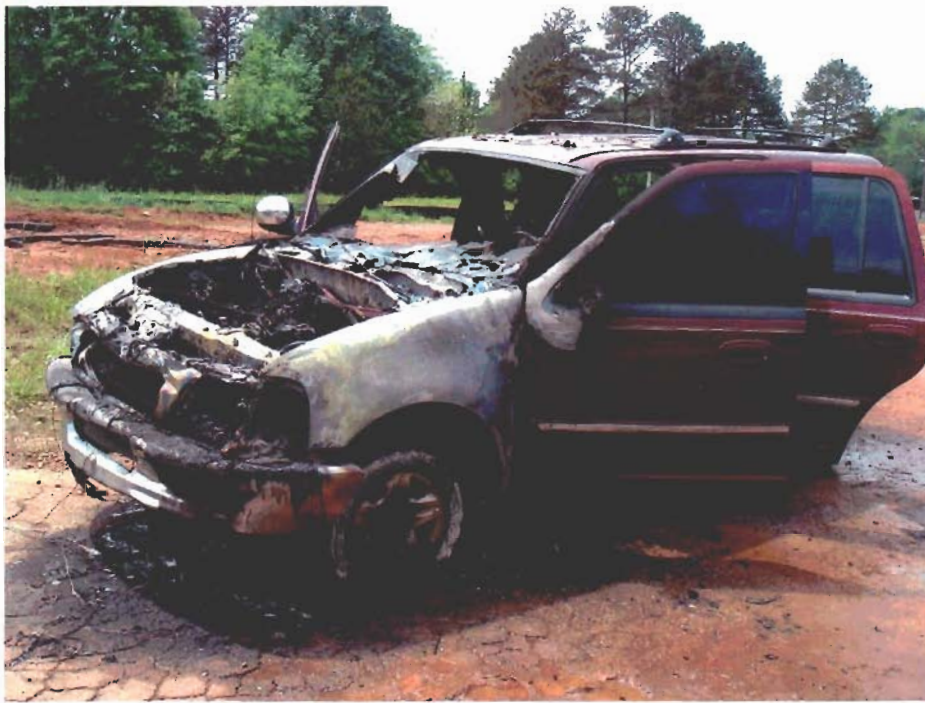
after the fires were extinguished (Figure 17), were used as a reference in evaluating complainant vehicle fires. Along with eye witness testimony, owner interviews, and physical evidence, the fire test data assisted ODI in determining if a complainant vehicle fire was likely to have been caused by a defective SCDS.

Figure 17. Burns Patterns On Test Vehicle.

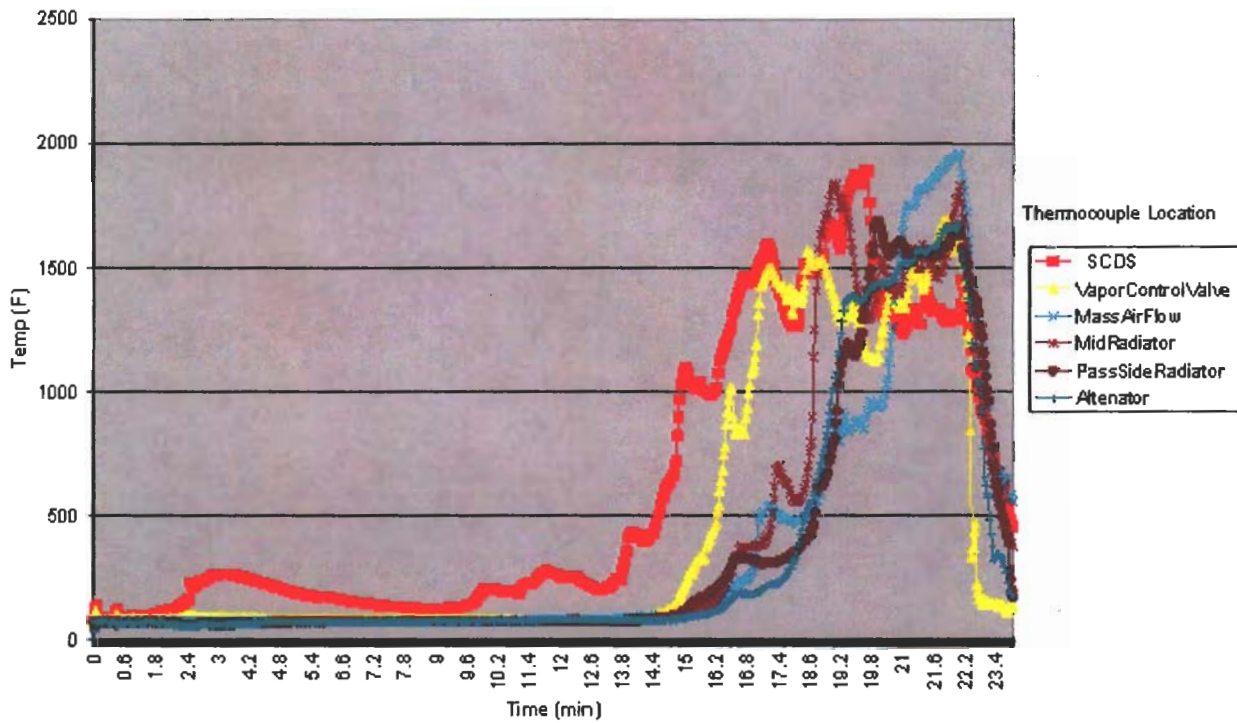
ODI observed four live vehicle burn tests to assist in determining if a fire reported to the agency was likely caused by the SCDS, and to prove that a SCDS could start a fire that could spread to the rest of the vehicle. The live burn tests were started by using a defective SCDS that was on the verge of catching fire. The vehicles were instrumented with under-hood cameras and 6 thermocouples located throughout the engine compartment. The vehicle fires were also video recorded from the exterior. The data and burn patterns collected from this series of live burns showed that a defective SCDS could catch fire and the fire could then spread to the remainder of the vehicle. The under-hood cameras and thermocouples documented how the fire spread, how hot certain areas got and how long it took for certain areas of the engine compartment to get involved in the fire (Figure 18.). This data, along with the burn patterns that were documented

Figure 18. Thermocouple Data From Live Burn Test Vehicle.

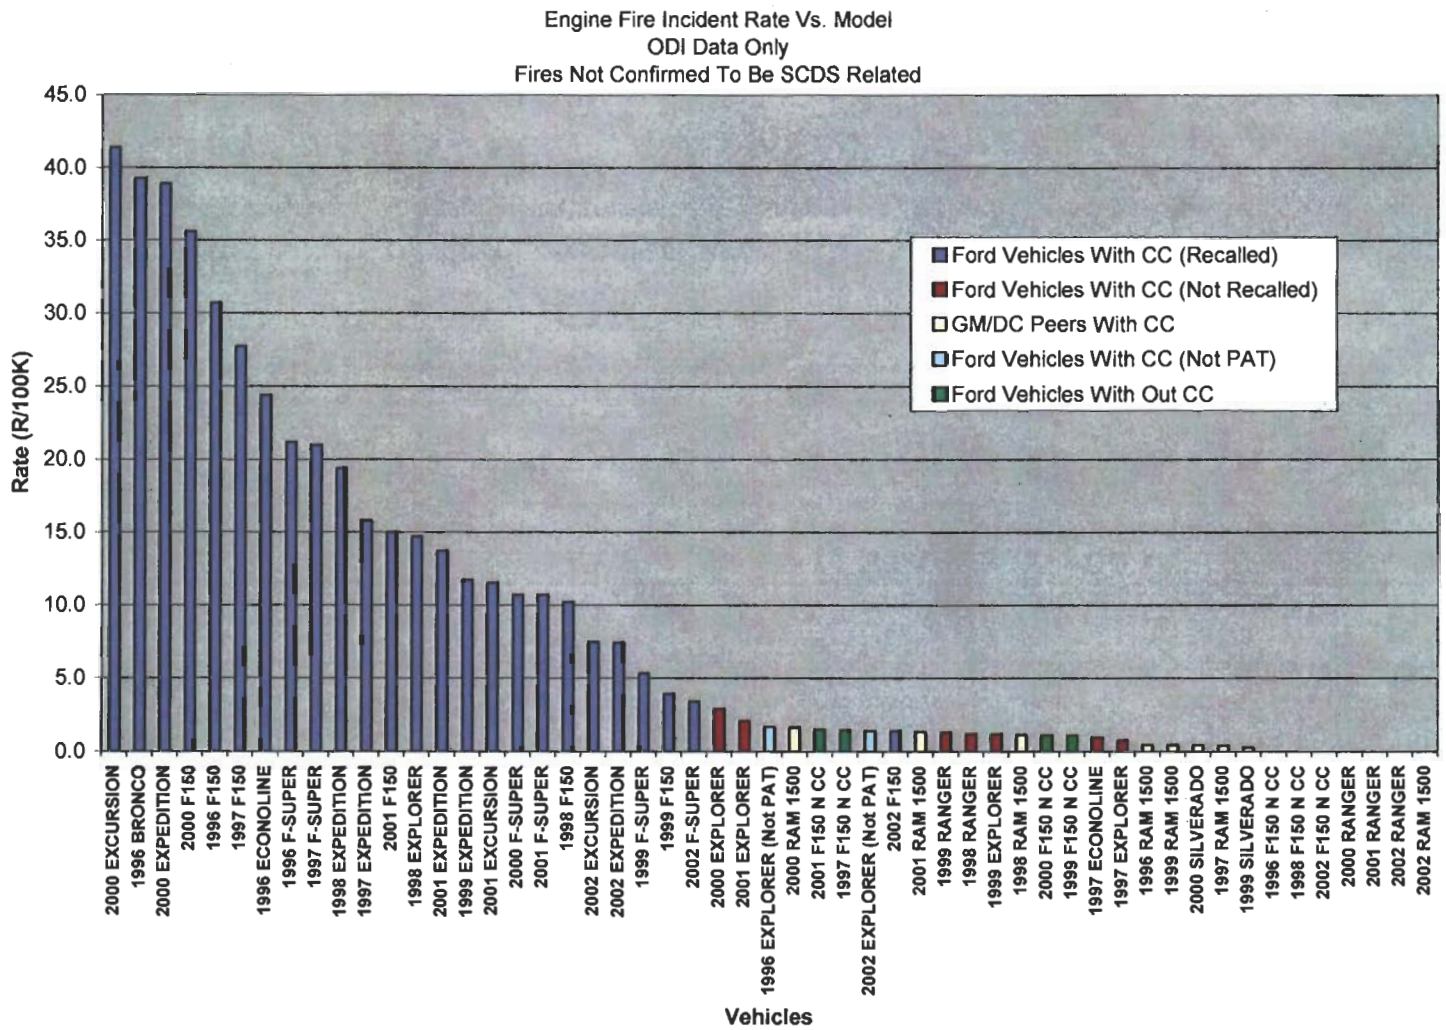
In order to better understand if the SCDS was the true cause of the fires in the Ford model vehicles equipped with cruise control, ODI determined the key off engine compartment fire failure rates on some peer Ford models manufactured without cruise control. ODI also determined the key off engine compartment fire failure rates for some peer Ford models that were manufactured with cruise control but where the SCDS was not PAT. A third group of peers that ODI collected complaint information on and determined complaint rates for were General Motors CK 1500 trucks and Daimler Chrysler Ram 1500 trucks. A comparison of these failure rates is shown in Figure 20.

In comparing the Ford models that have a high rate of key off, engine compartment fire (Figure 20.) to the models that exhibit the three factors identified as the primary factors in causing SCDS related fires (Table 1.), it can be seen that the models exhibiting these factors are also the models with the highest rate of fire. This correlation provides support for the position that these three factors: (1) The SCDS is contained in a PAT circuit; (2) The SCDS is mounted in a vertically up or angled down orientation; (3) The brake system produces vacuum levels that cause the Kapton diaphragms within the SCDS to flip orientation; are the likely root cause for the fire related failures of the SCDS.

Figure 20. Key Off Engine Compartment Fire Complaint Rate Data.
