Reconstructing the James Dean Crash (Part 1 of 3)

As you know, this tragic crash occurred September 30, 1955 at 5:45 pm near Cholame, California. It has been the subject of many independent investigations and research studies over the years. Recently, National Geographic decided to review it again using a different approach and new crash science.

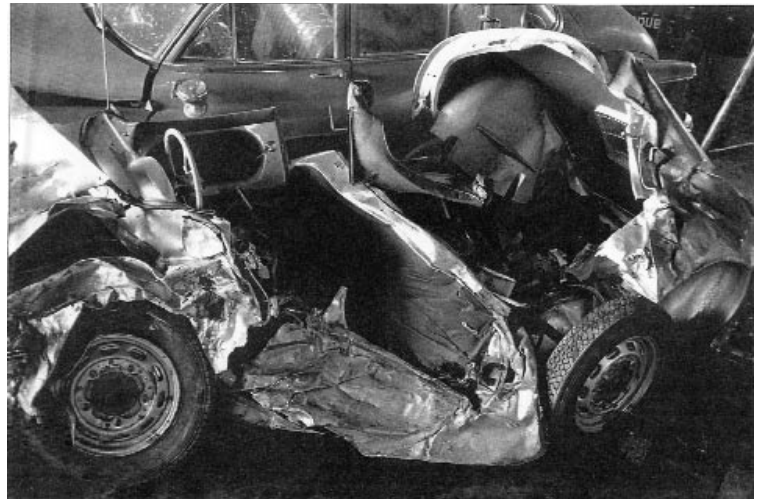
We were provided with a series of photographs of the scene taken by CHP Officers. We were also supplied with their reports and a sketch. The sketches were great for 1955 but lacked the accuracy of modern day scale diagrams which would allow precise speed analysis and vehicle positioning. As you can see in the scanned images, bits of information from all of this material had to be assembled to allow a scene reconstruction

...the sketches were great for 1955, but lacked the accuracy of modern day scale diagrams...

The supplied background information then had to be supplemented with the crash scene measurements of the overall geometry. These simply did not exist. As one can see the sketch, not only was not to scale, but was not based on any measurement protocols and was geometrically inaccurate. That meant developing the overall scene diagram as a separate task, and then integrating the evidence
